Re: **Release of Surety, Calliham Mine, Permit Number M/037/023**

# **EFFECTIVE RECLAMATION TECHNIQUES**

## **Calliham Mine**

Utah Division of Oil, Gas and Mining Permit M/037/023  
San Juan County, Utah

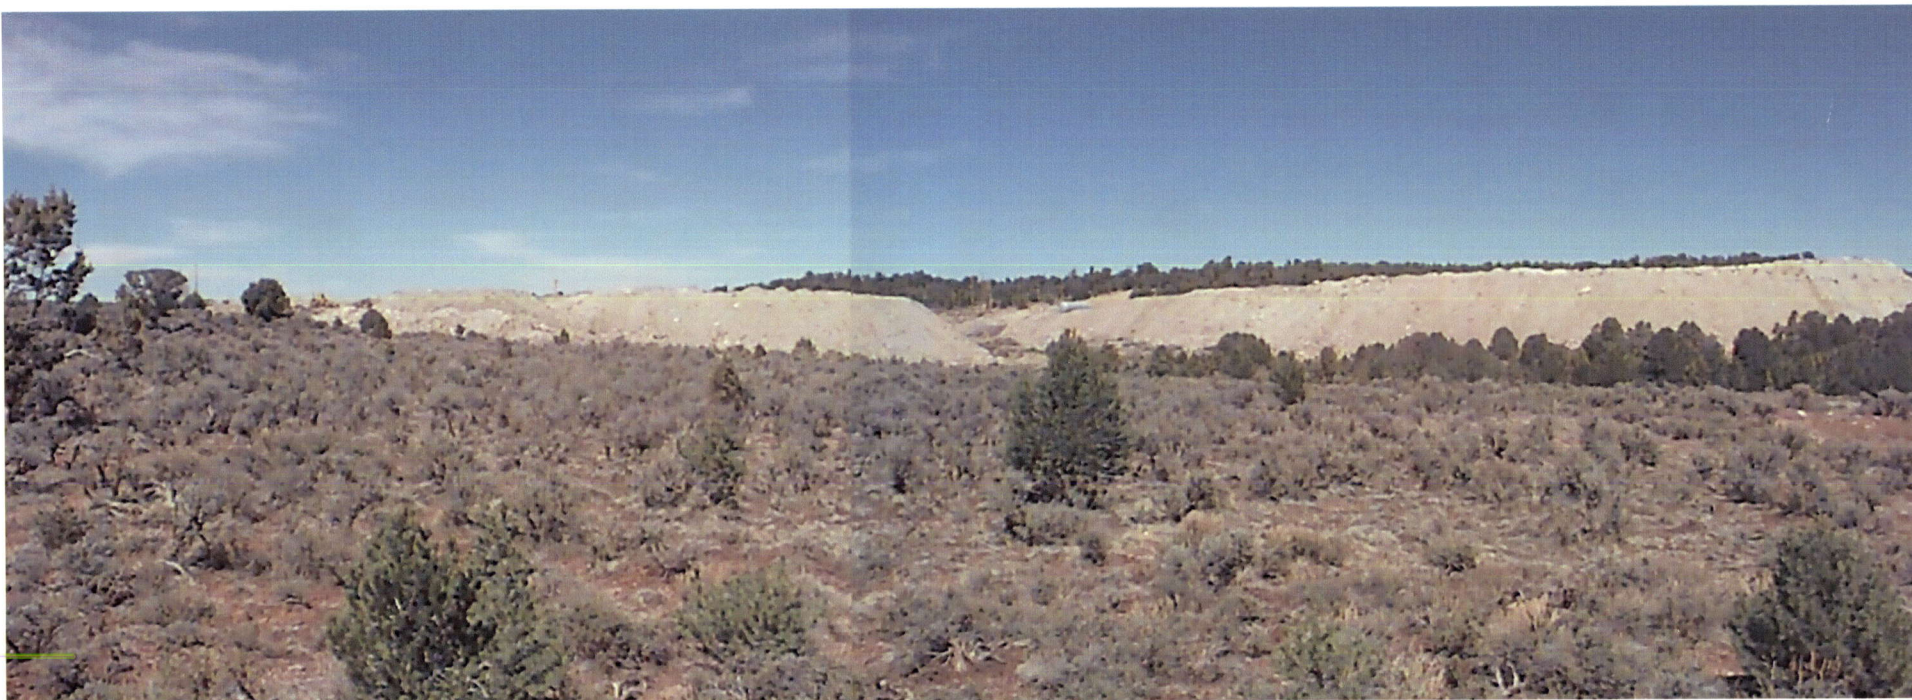
**Figure 1** Stockpile B and Mine Spoils Pile (looking northeast)

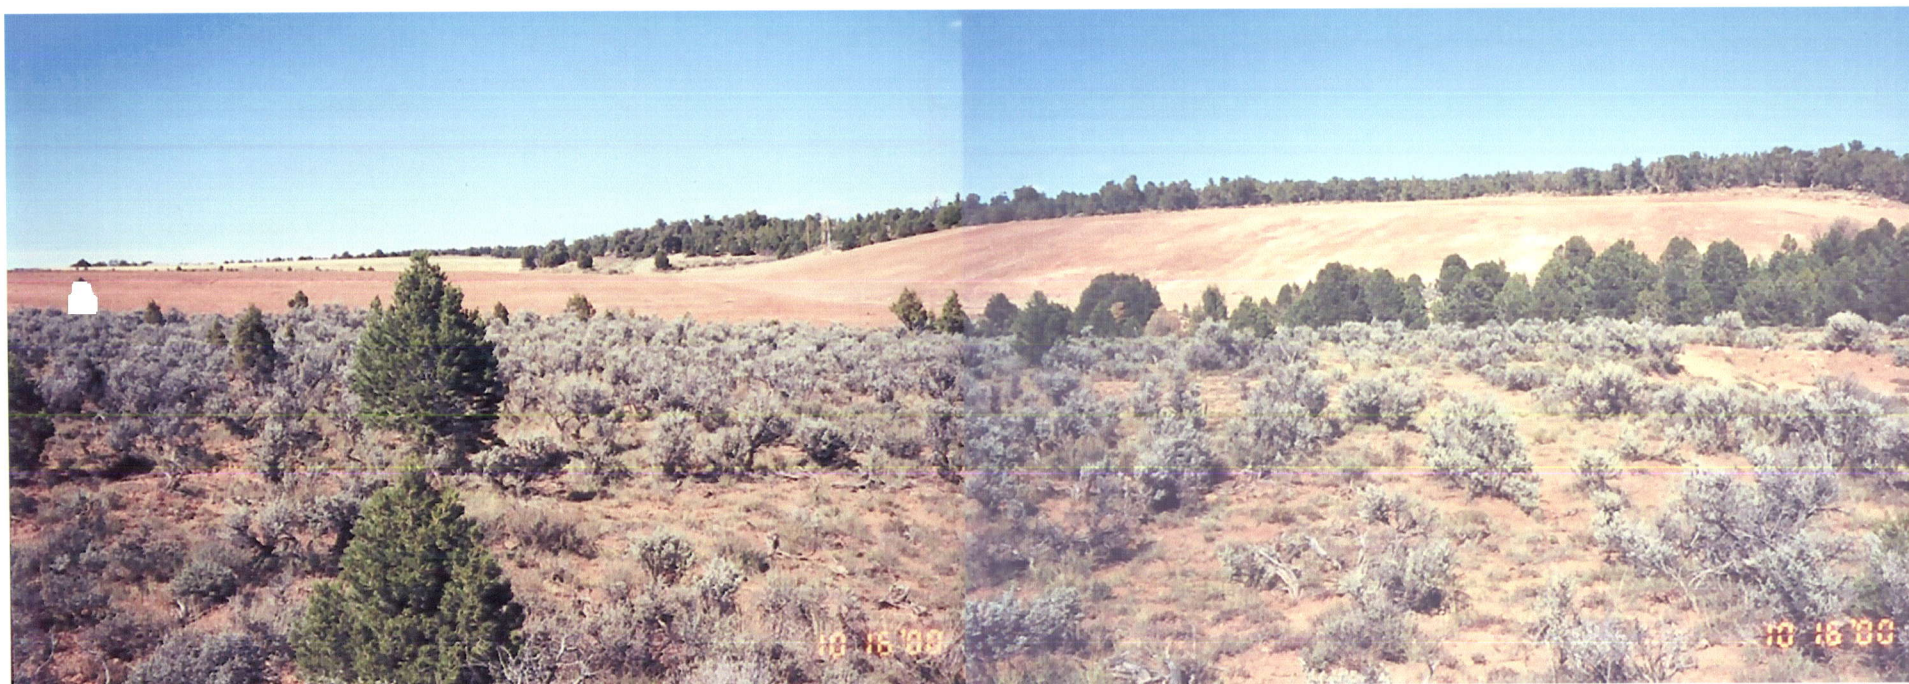
**Figure 2** Stockpiles A and B, Drainage, Mine Spoils Pile Area (looking north after reclamation)

The Calliham Mine is a large underground uranium/vanadium mine in southeast Utah that operated from 1973 to 1991. Atlas Minerals Corporation obtained the original mine permit in 1977 and Umetco acquired the permit in 1988. The ore bodies were accessed by rubber tired equipment through a decline. Operations began before reclamation laws were enacted, and mine spoils were placed with little thought of future environmental considerations (Figures 1 and 3). Topsoil was not salvaged prior to mining, and mine spoils were placed in drainages. In 2000, using unique techniques to borrow topsoil onsite, Umetco successfully reclaimed the entire site to range land (Figures 2 and 4).

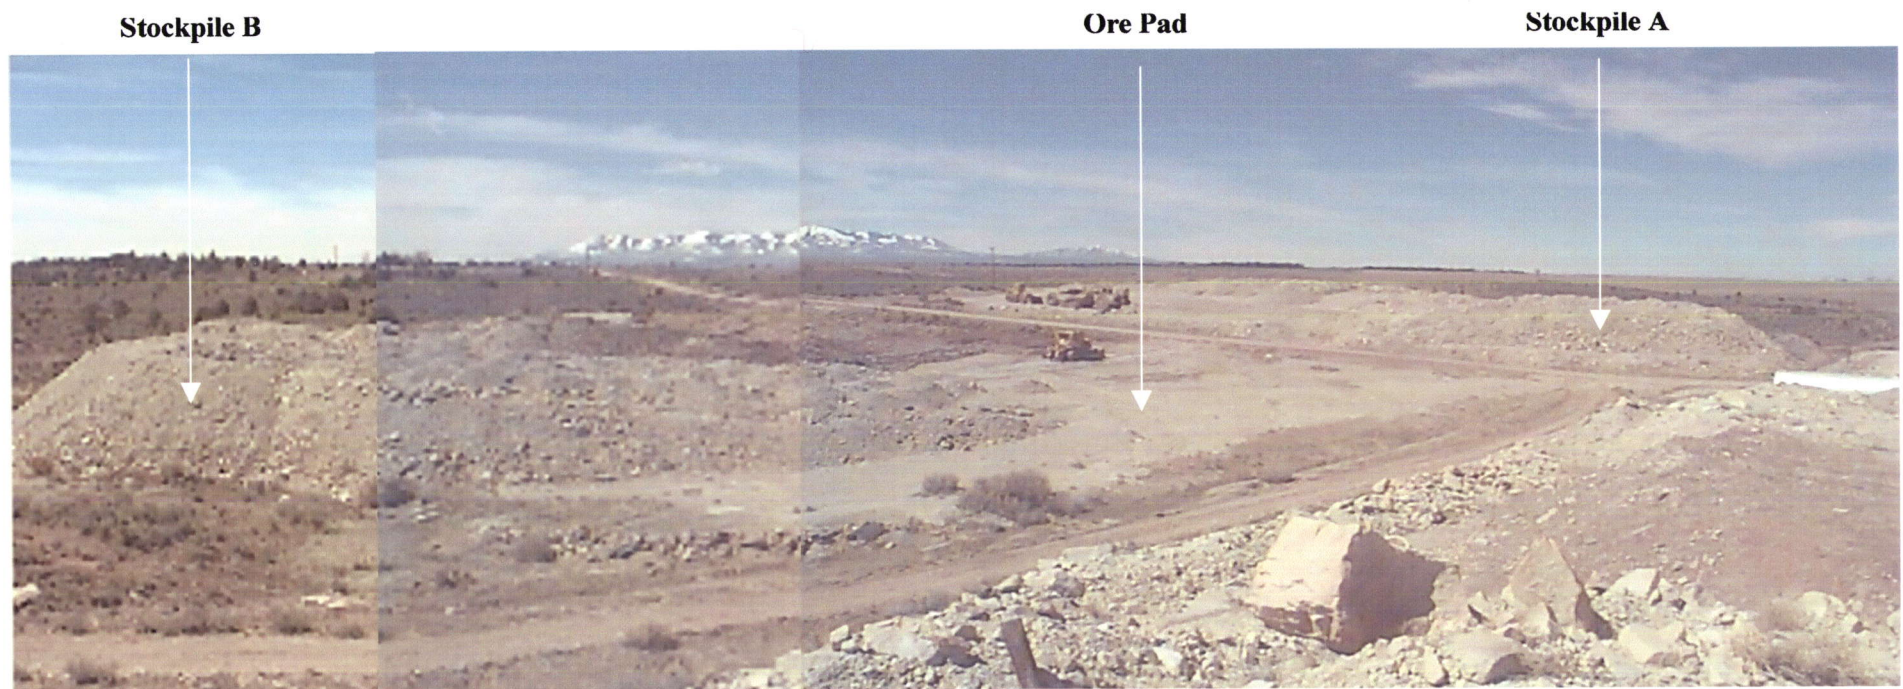
**Figure 3** Stockpile A, Ore Pad, Stockpile B, Access Road and Main Drainage

Figure 5 is an aerial view of the site before reclamation. Mine spoils were deposited southeast of the portal. The spoils approached drainages on both the east (auxiliary drainage) and south (main drainage) sides of the mine spoils pile, and an access road was constructed of mine spoils in the main drainage. The mine spoils pile also completely blocked a small basin (north basin). Two large low-grade ore piles (A and B) and an ore pad to the southwest of the mine spoils pile were also developed (Figures 3 and 6). No topsoil was salvaged during the creation or operation of any of the spoils piles.

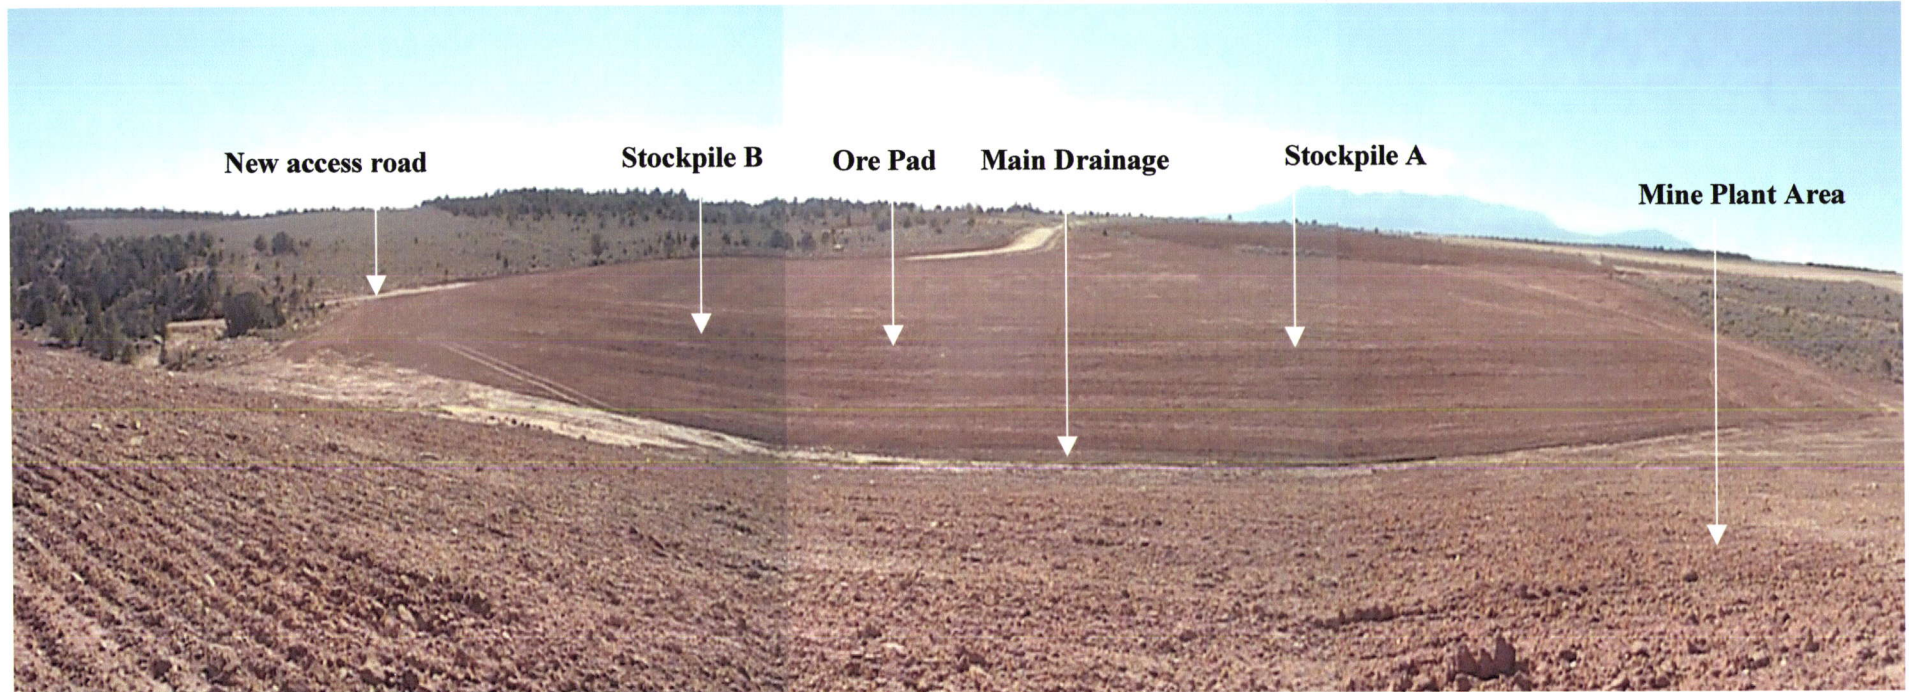
**Figure 4** View from Mines Spoils Pile Area (after reclamation looking southwest)

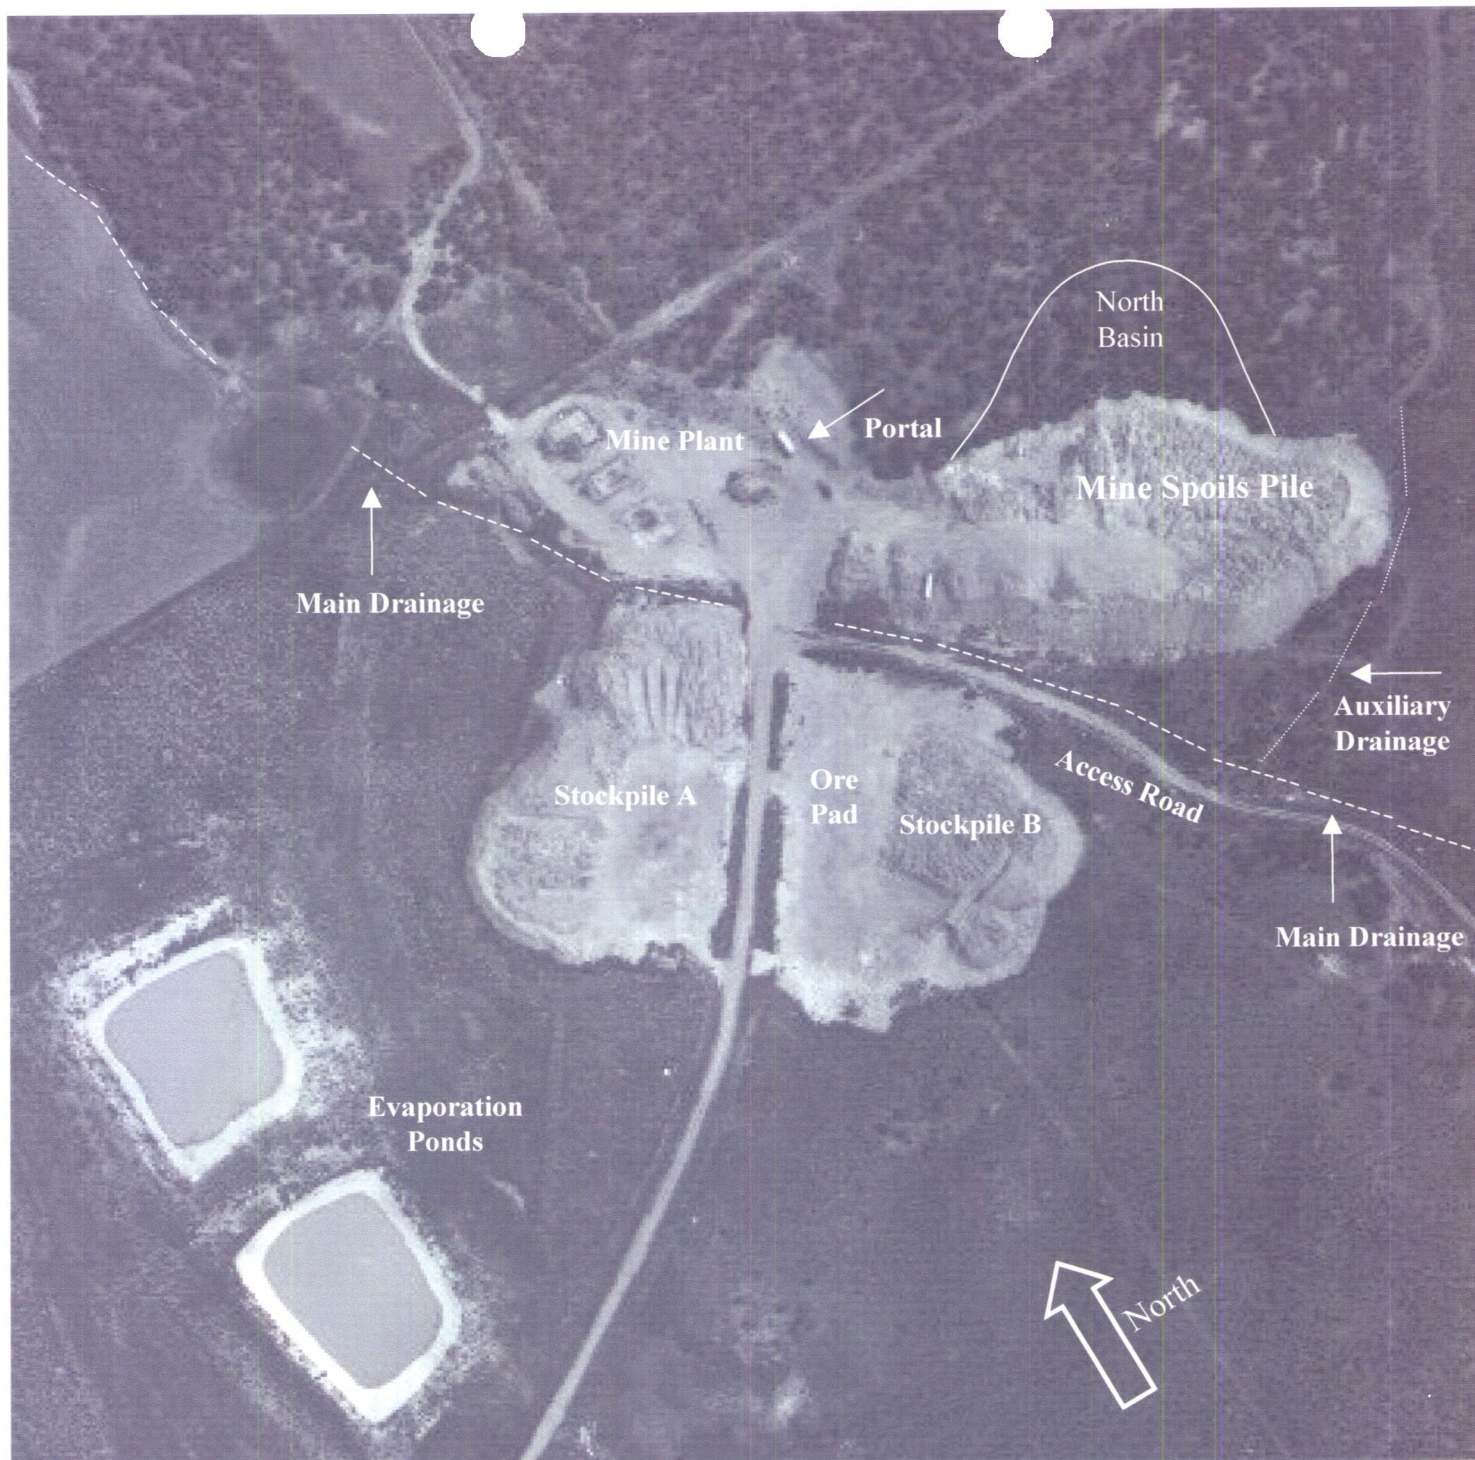
**Figure 5**  
**Calliham Mine**

Permit M/037/023 -- San Juan County, Utah  
**1992 Aerial View**

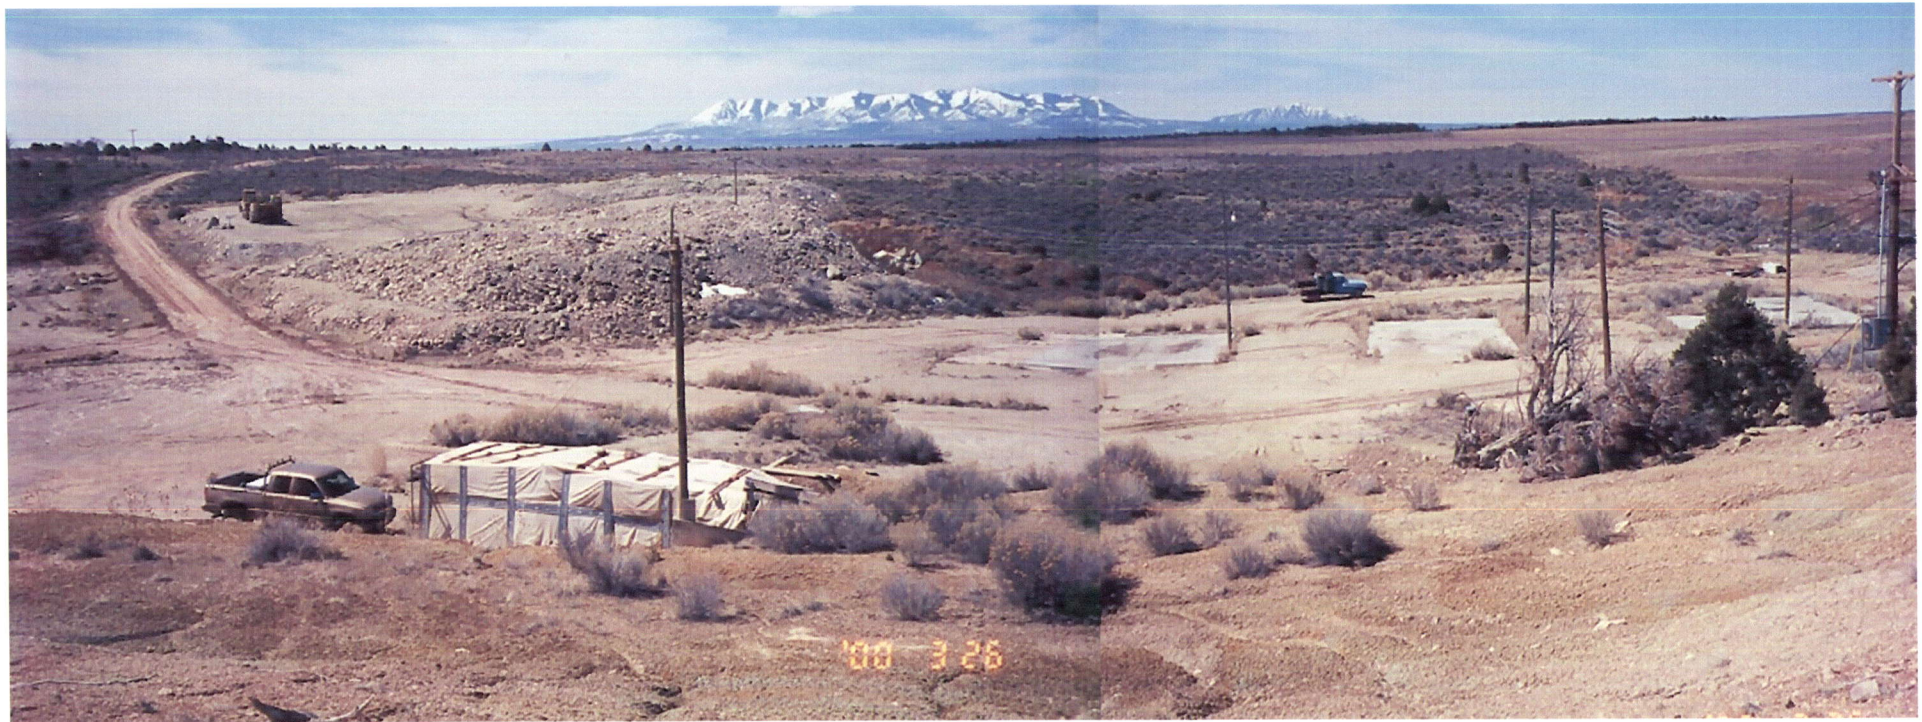
**Figure 6**  
Stockpile A, Portal, and Mine Plant Area  
(looking west)

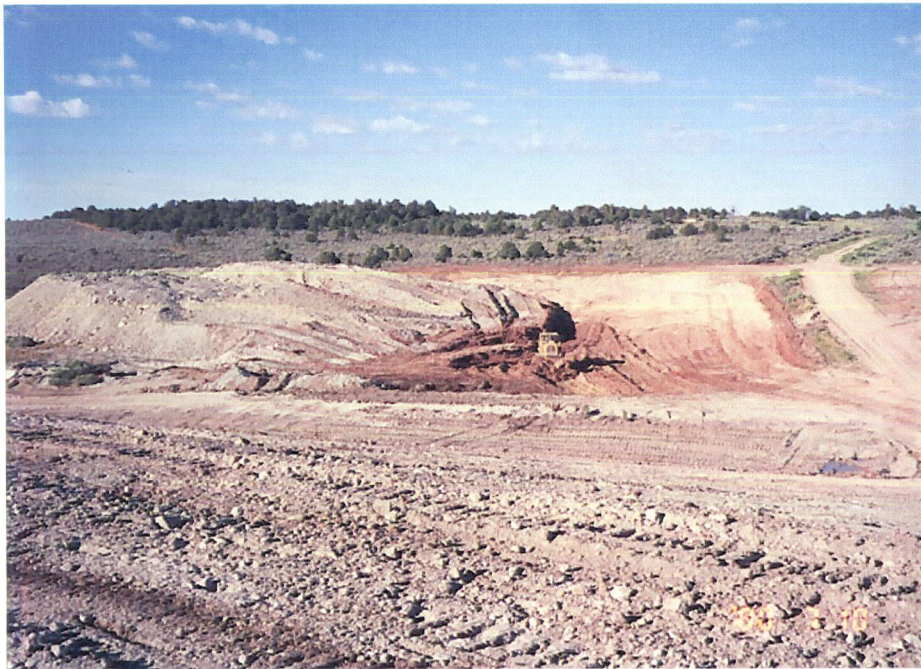
**Figure 7** Salvaging topsoil from borrow area underneath ore pad location

Backfilling the trenches and borrow area with mine spoils effectively made Stockpiles A and B disappear. All disturbed areas were covered with at least 6 inches of topsoil, and all topsoil was borrowed from previously disturbed areas (Figures 7 and 8). The site was seeded in the fall of 2000 and should be ready for post-mine land use in two years. Thus the Calliham Mine site (having no salvaged topsoil) was successfully reclaimed leaving no sign of previous mining activity.

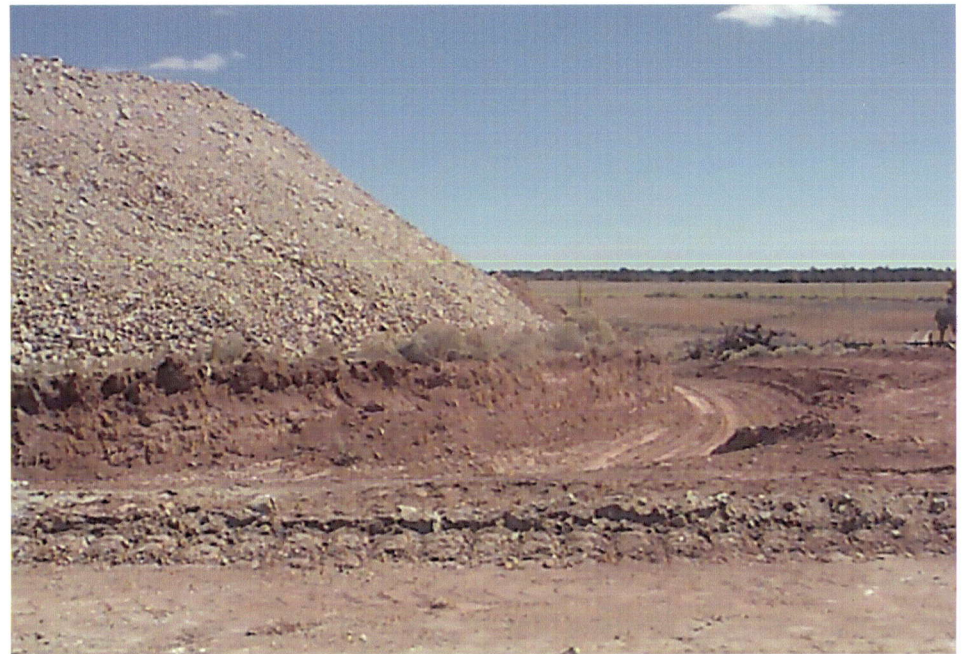
**Figure 8** Salvaging topsoil by trenching around the toe of the mine spoils pile
